TS-590SG Cooling Fan Fix

Gary - AC6EG

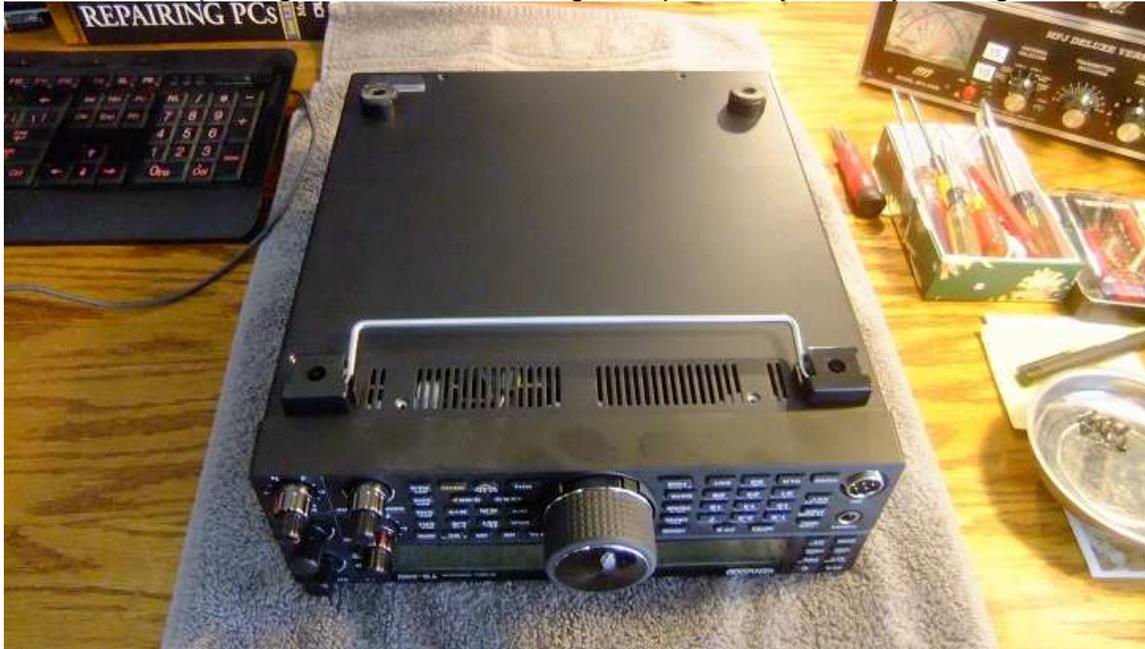
Begin by removing the 10 screws on the bottom & sides of the case.

I recommend putting the screws in a magnetic parts tray so they don't get lost.

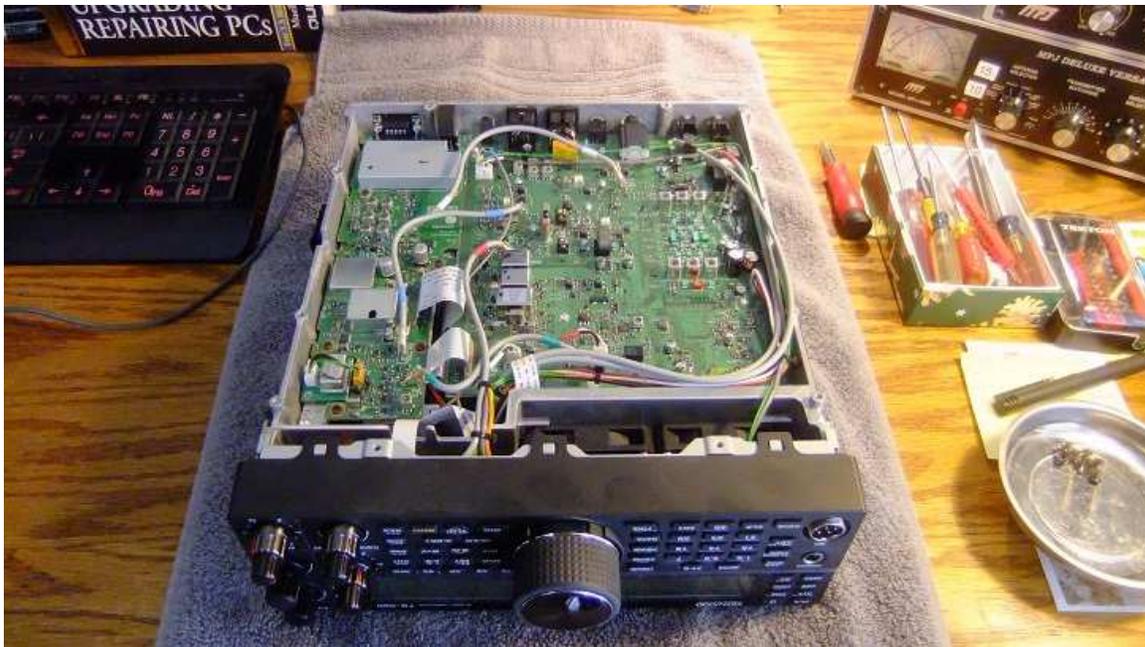
Remove the bottom case.

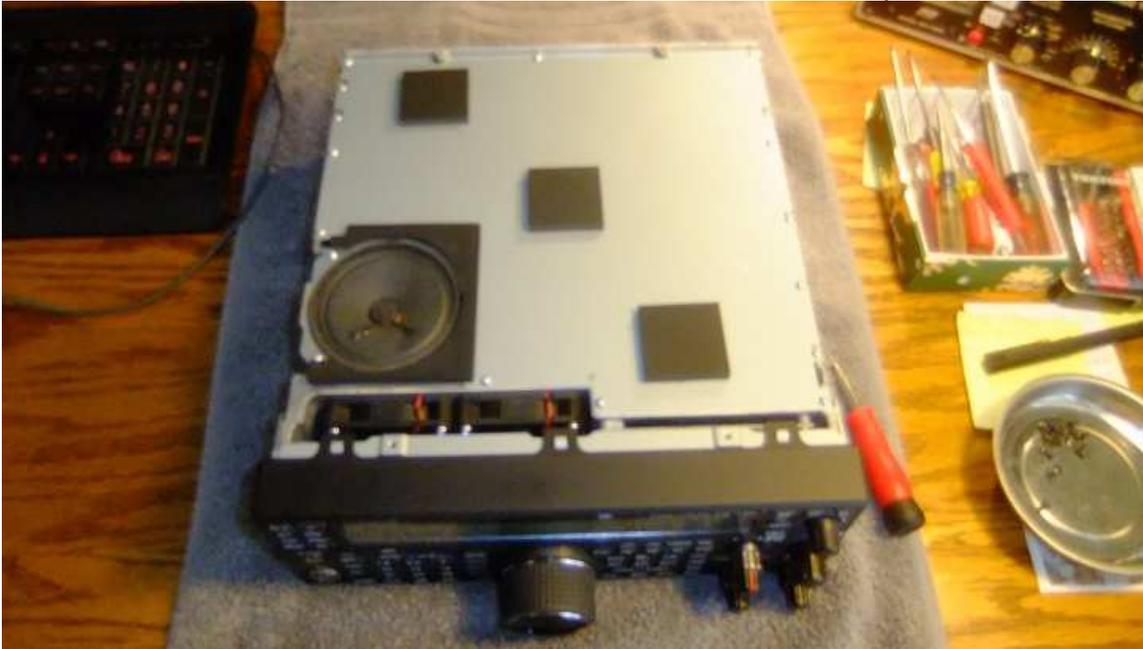
Turn the radio over, remove four more screws and lift off the top case:

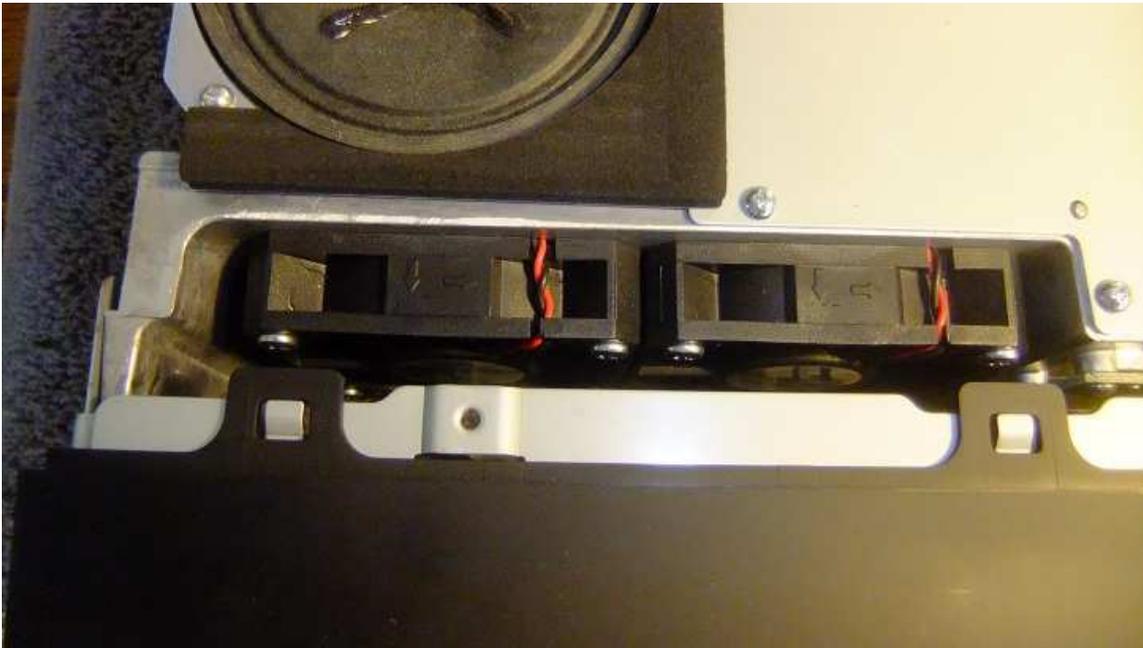
Arrows embossed on these two cooling fans show air flow is incorrectly directed toward the front of the radio:

Remove the fan mounting screws and carefully lift the wires out of the notches in the fan frames. Turn the fans around and reinstall them with the air flow arrows pointing toward the back of the radio.

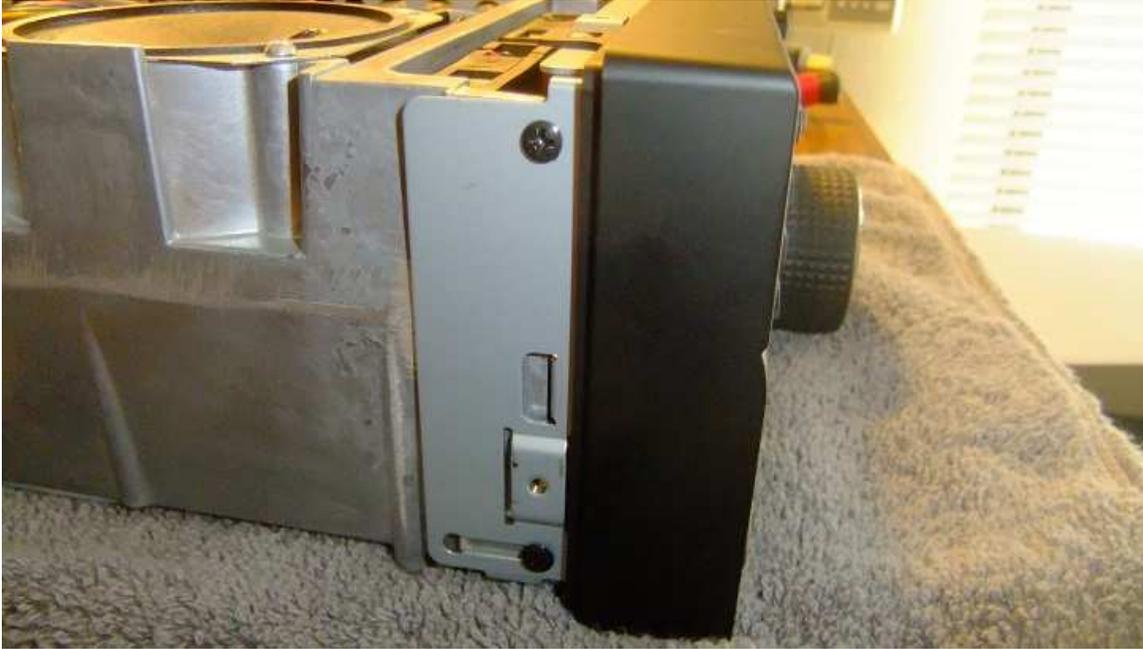
Loosen the bottom screws and remove the top screws at the sides of the front panel. Do not remove the bottom screws.

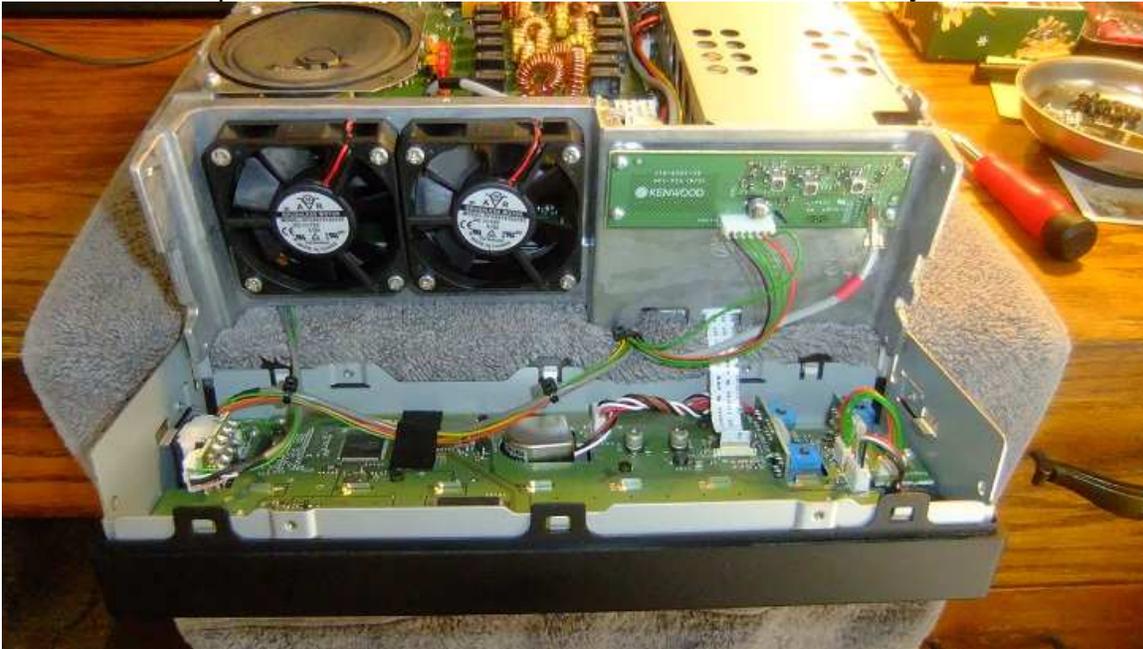
Allow the front panel to tilt down out of the way over the edge of table or workbench. You do not need to disconnect any wires. I removed the sheet metal shield on the top of the chassis, but found that was not necessary.

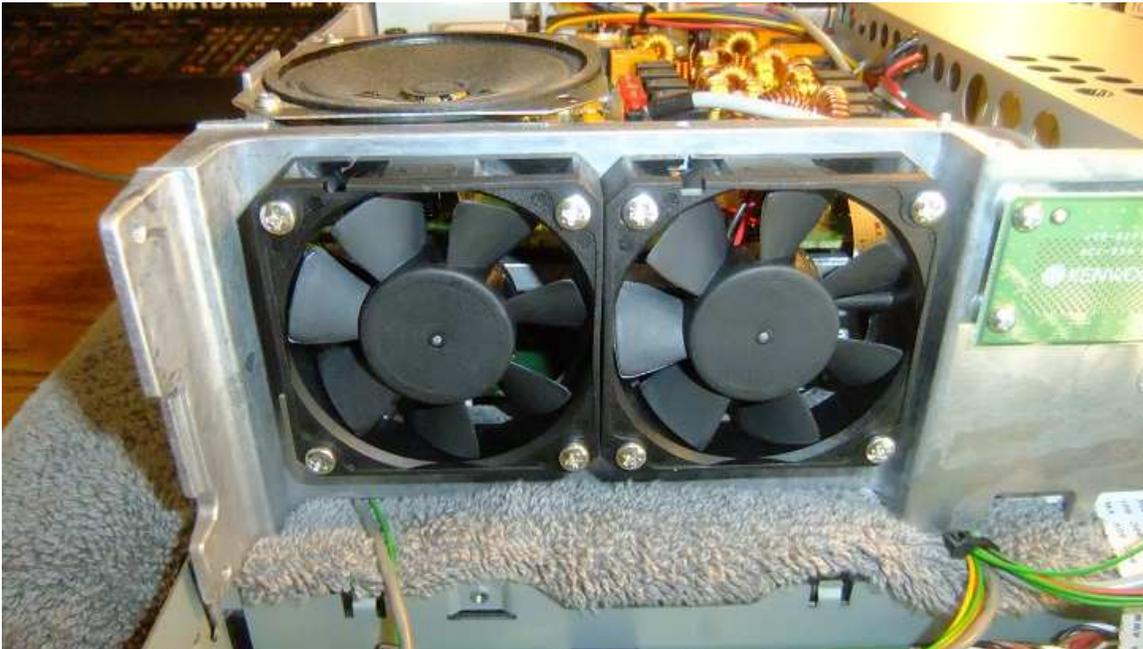
When you are done, the fans should look like this. Make sure the wires are clear of the fan blades:
